Manhole Inspection Summary

Manhole # S09MM1022MH

Location Address: **4900 DENMORE AVE**

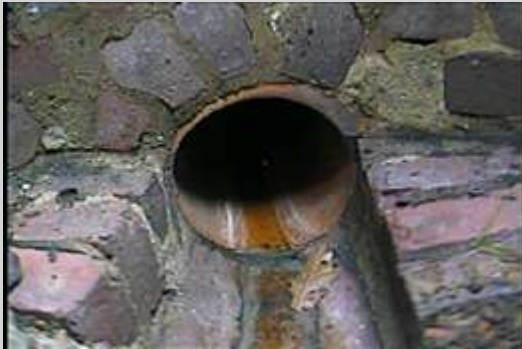
12 O'Clock Outflow

8 in. Circular Gravity Sewer
Pipe Out @ 12 O'Clock

Pipe Height: **8.4** (in.) Rod and Bar (Angled)
Pipe Material: **Clay** ☐ Pipe Lined
Invert Depth: **4.62** (ft.) Flow Characteristics: **Slow**
Deposits: ☒ None ☐ Mud ☐ Sludge ☐ Debris ☐ Grease
Silt Depth: (in.) Deposits Extent:
Infiltration: **None** Pipe Seal Cond: **Sound**
